DEPARTMENT OF TRANSPORTATION**DIVISION OF ENGINEERING SERVICES**

Contract #: 04-0120F4Cty: SF/ALA Rte: 80 PM: 13.2/13.9File #: 69.15**SOURCE INSPECTION REPORT****Resident Engineer:**Pursell, Gary**Address:** 333 Burma Road**City:** Oakland, CA 94607**Report No:** SIR-002262**Date Inspected:** 30-May-2010**Project Name:** SAS Superstructure**OSM Arrival Time:** 700**Prime Contractor:** American Bridge/Fluor Enterprises, a JV**OSM Departure Time:** 1900**Contractor:** Zhenhua Port Machinery Company, Ltd (ZPMC), Changxing Island **Location:** Shanghai, China**Quality Control Contact:** Mr. Don Walton**Quality Control Present:** Yes No**Material transfer:** Yes No N/A**Sampled Items:** Yes No N/A**Stock Transfer:** Yes No N/A**OK to Cut:** Yes No N/A**Rebar Test Witness:** Yes No N/A**Delayed/Cancelled:** Yes No N/A**Other:** Coating Inspection**Bridge No:** 34-0006**Component:** See Below**Bid Item:** 77, 78, 79**Lot No:** B #204**Summary of Items Observed:**

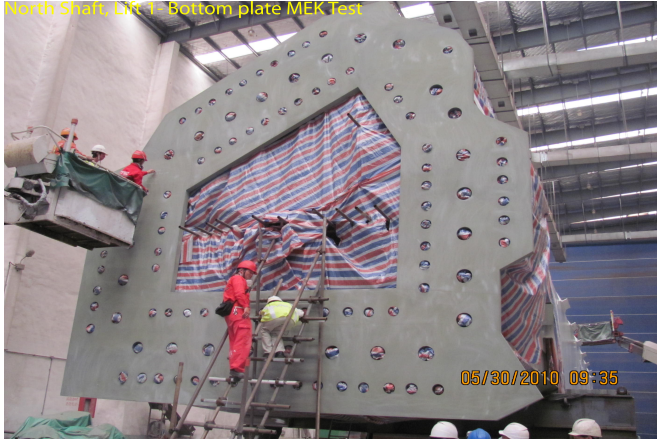
2. An inspection was requested for the North Tower base plate external side MEK, Pencil hardness test vide notification no. T 532. This Caltrans inspector observed, ABF inspectors Mr. Turtle and Mr. Vince performing said inspection check carried out by ZPMC QC inspectors. This test was carried out in 1 place and the result found to be in the Grade 5, which is acceptable as per contract documents. International protective coatings technical service representative was not found present during the course of this inspection process. (Photograph attached)

North Shaft, Lift 1- Bottom plate MEK Test

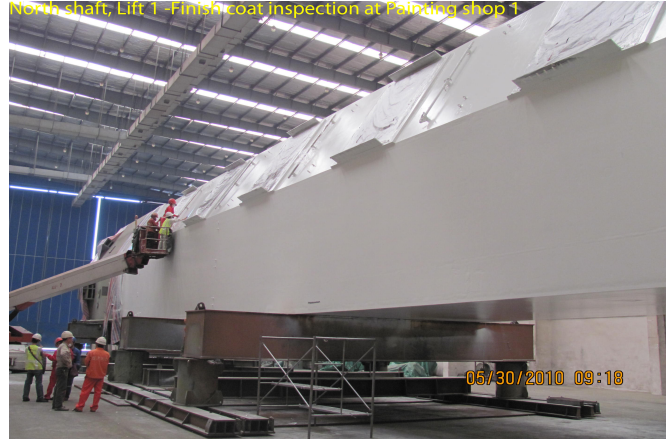
1. An inspection was requested on the North Tower, Lift 1-External Finish coat application inspection, vide request no. T 529 at Painting shop 1. This Caltrans inspector observed, ABF inspectors Mr. Turtle and Mr. Vince performing said inspection check. It was observed that, these external surfaces were rejected by ABF Inspectors for Mudcrack, Sagging and Excess spray in some of the areas. The ambient conditions were monitored and is 5.6 deg. above dew point and the relative humidity found to be 61.8% which is acceptable as per contract documents. The External surfaces again offered for inspection vide notification no. T-533, and the same found again rejected by ABF inspectors for some of the local touch up points have not been attended. International protective coatings technical service representative was found present during the course of this inspection process. Photograph showing ABF inspectors doing inspection is attached with this report.

North shaft, Lift 1 -Finish coat inspection at Painting shop 1
